# SERVICE INFORMATION

Motorcycles R50/5, R60/5, R75/5  
Group: Engine

München, July 1970  
No. 7/70 (288) en.

Re: Through-bolt sleeves pressed into cylinder head

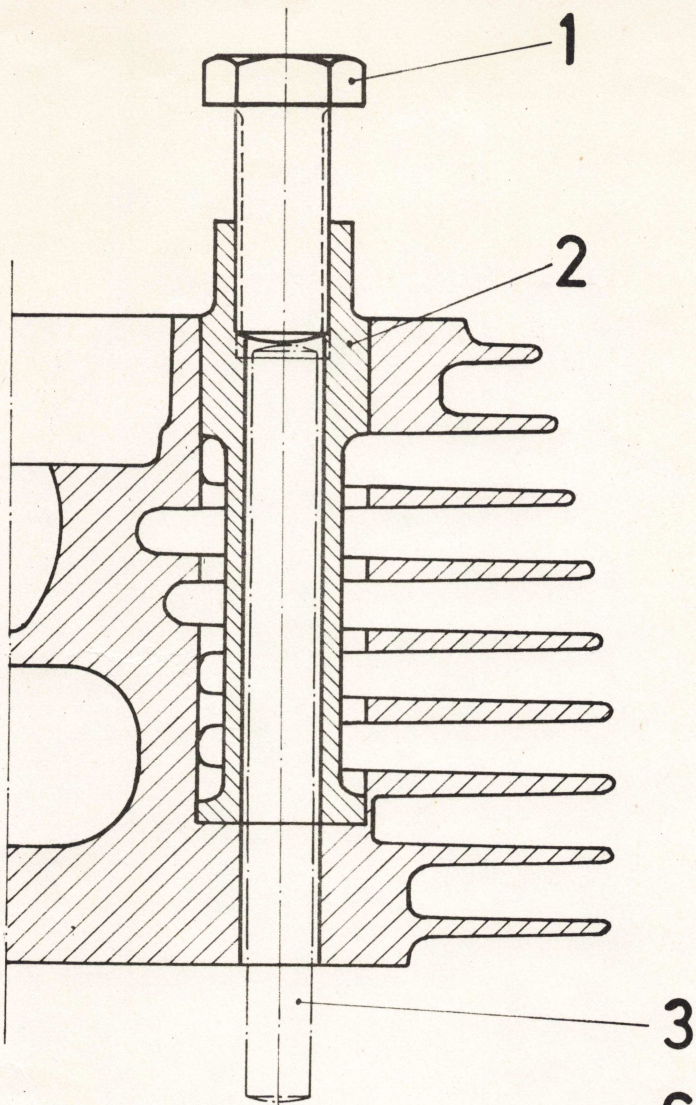
I

In order to avoid oil leakages between cylinder head and through-bolt sleeves in case of unfavorable machining tolerances, new through-bolt sleeves with seal rings (O-ring) and spacers are now used on

Screw M 12 bolt (1) into pressed-in sleeve (2), tap the pressed-in sleeve with appropriate drift (3) (10 mm  $\emptyset$ , approx. 160 mm long) out of cylinder head, see sketch I.

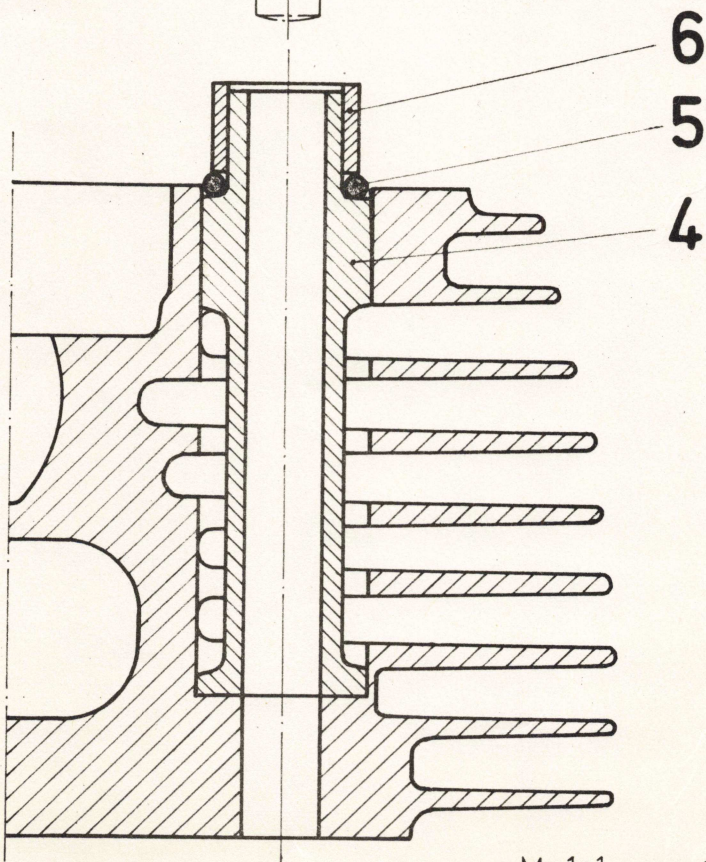
II

The upper guide of the new through-bolt sleeve is by approx. 1.8 mm shorter than the previous version. Thus results, with built-in through-bolt sleeve an annular section for the lodgement of the O-ring.

When tightening the cylinder head, the O-ring is pressed, through a spacer, against the through-bolt sleeve and its lodging bore in the cylinder head. This assures an efficient sealing between cylinder head and through-bolt sleeve, see sketch II.

Tap new through-bolt sleeve (4) into still warm cylinder head. Slide-on O-ring (5) and spacer (6), see sketch II.
