# Service-Information

Group 11 Engine	May 1983	Bulletin No.: 11 024 83 (2077)
--------------------	-------------	-----------------------------------

RE: INSTALLATION OF THE OIL FILTER HOUSING CANISTER

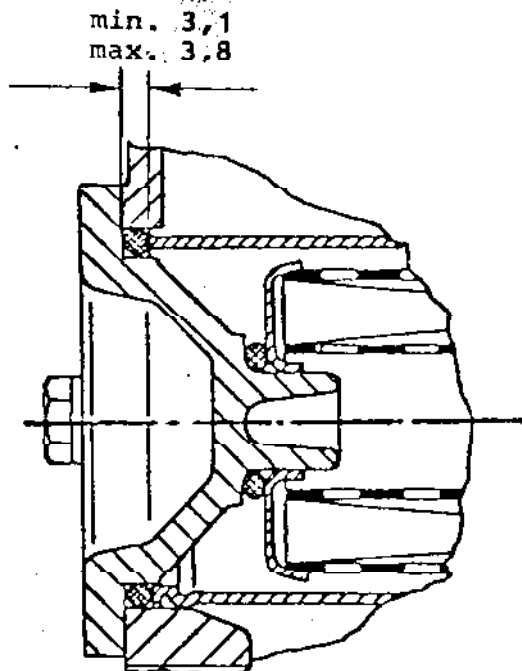
With the introduction of the R65 and change in the oil passages on all motorcycles beginning in 1980, it is possible in isolated cases that a small oil pressure drop can occur.

The distance between the oil filter cover surface and the face of the oil filter canister sleeve should be as referenced in the line drawing. Excessive clearance will cause a poor seal between the cover and canister sleeve and oil pressure will be reduced or fail.

Should the clearance be as described below, we suggest referring to Service Information 11 011 78 (1061R) for further details.

We suggest that during any service or rebuilds, the depth of the oil filter canister sleeve to crankcase cover be measured.
