This article is written after a lengthy discussion with Ed Korn about BMW /2 crankshafts, balancing and straightening. In this discussion some ideas popped up, that are not universally known among the vintage BMW fraternity. So I decided to write them down on this webpage, so everybody can benefit from the result. I appreciate how Ed helped me out with these issues.

The /2 has a very good crankshaft, that was a good piece of engineering in its heyday. But they are old now, and when compared to modern technology they are a bit dated and need some extra attention.

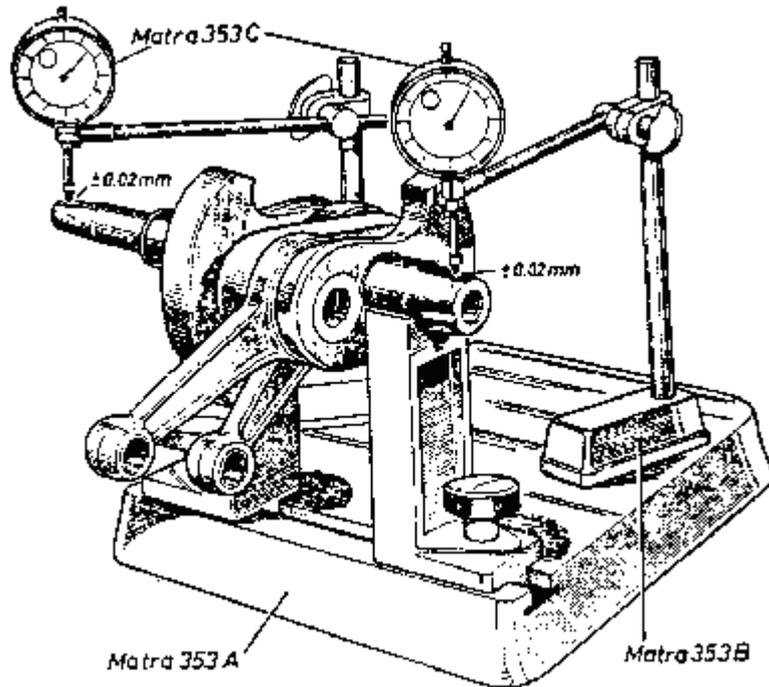
Check if the crank is true. You find this in every BMW workshop manual. You put the crank with its main bearing journals on V-blocks, and put a dial gauge on the very end of the dynamo and the flywheel taper. It shouldn't be more than 0.02mm out of round. A dial gauge and a stand also belong to the standard equipment of home restorer. Also these are very cheap today. You can buy V-blocks, but you can also make your own. Cut both V's together, and file the corners nice and smooth. If you use angle iron, you can mount them with long screws on a base plate, using blocks to get the right height.

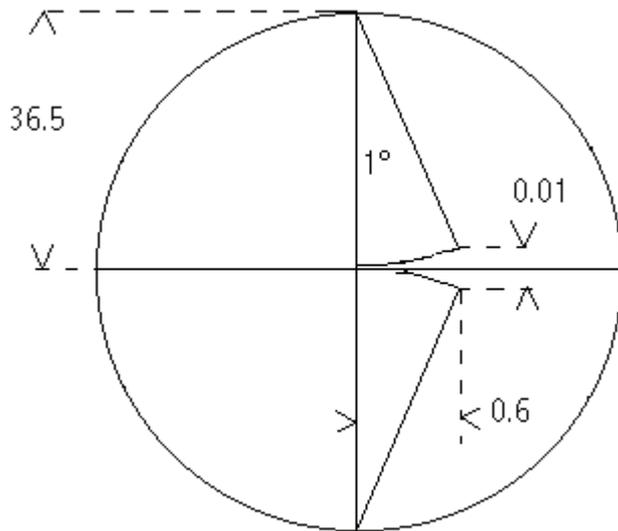
Maybe in those days you only bought cranks from the factory, and these were assumed to be good. But a little bit of reasonable thinking and high school geometrics will show that you can turn a BMW boxer crank in a 178 degree crank, before it shows up into the 0.02mm measurement of the above mentioned check. This causes not only a bad ignition balance, but also a bad weight balance. The distance between the two bearing journals is about the same as the length of the dynamo taper. So what you measure with the dial gauge on the end of the dynamo taper is twice the amount the bearing journals are out of line. When you hit one crankweb with a hammer, it will turn around its corresponding crankpin. If you hit it so hard that the dynamotaper is 0.01mm out of line, you will register a 0.02 mm out of roundness on the dial gauge when you put it back on the V-blocks. The same goes for the other crankweb, or if you wedge the crankwebs apart or press them together. This is all nice and simple for a single cylinder, but not for a boxertwin. Here you can hit both webs in the same direction, while holding the middleweb steady in a vice or so. Looking the crankshaft in the face, you will get a picture like this:

The flywheel and the dynamo taper will stay reasonably in line for a very long time, so you can pull them 0.6mm from the centreline before you register 0.02mm on the dialgauge. In that case you have a 178 degree crank, and a very real weight imbalance, because the middle web runs 0.6mm out of line. The average engine shop is not aware of this weird feature.

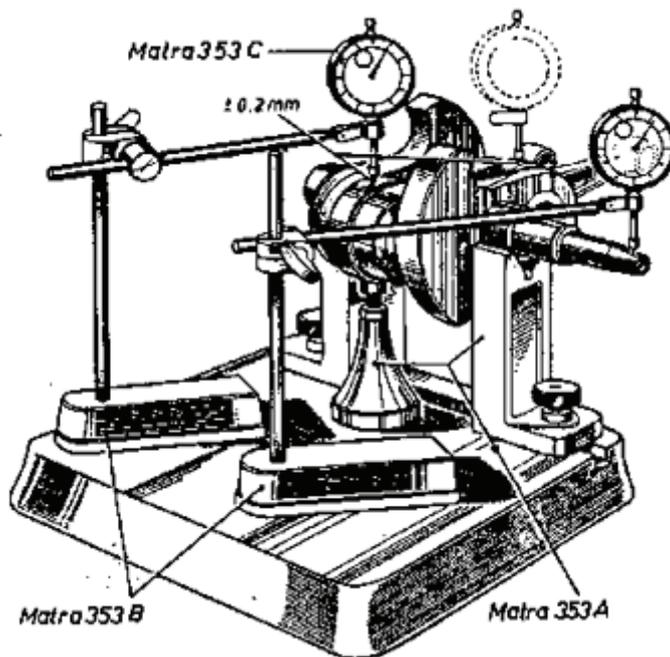
So how do check for this? The R51/3 workshop manual has a nice picture how you could do it:

You set this up until the dial gauge measures the same on both connecting rod big ends. Then without changing the setting of the jack support or the dial gauge, you turn the crank over and do the same measurement. They should be equal. But the outside of the connecting rods is very rough, and all this moving around of dial gauges doesn't help. But you are looking at a tenth of millimeters measurement, not hundreds. So maybe you get good enough results.

How precise should it be? The /3 manual says: Admissable crankshaft out of line is within 0.2 mm. Then each crankweb is 0.3 degree out of line, thus the difference between both top dead centres is 0.6 degree. The weight imbalance is now back to a few gram. In this examples I used the 600 cc engine dimensions, but the difference with the shorter stroke of the R50 is very small.

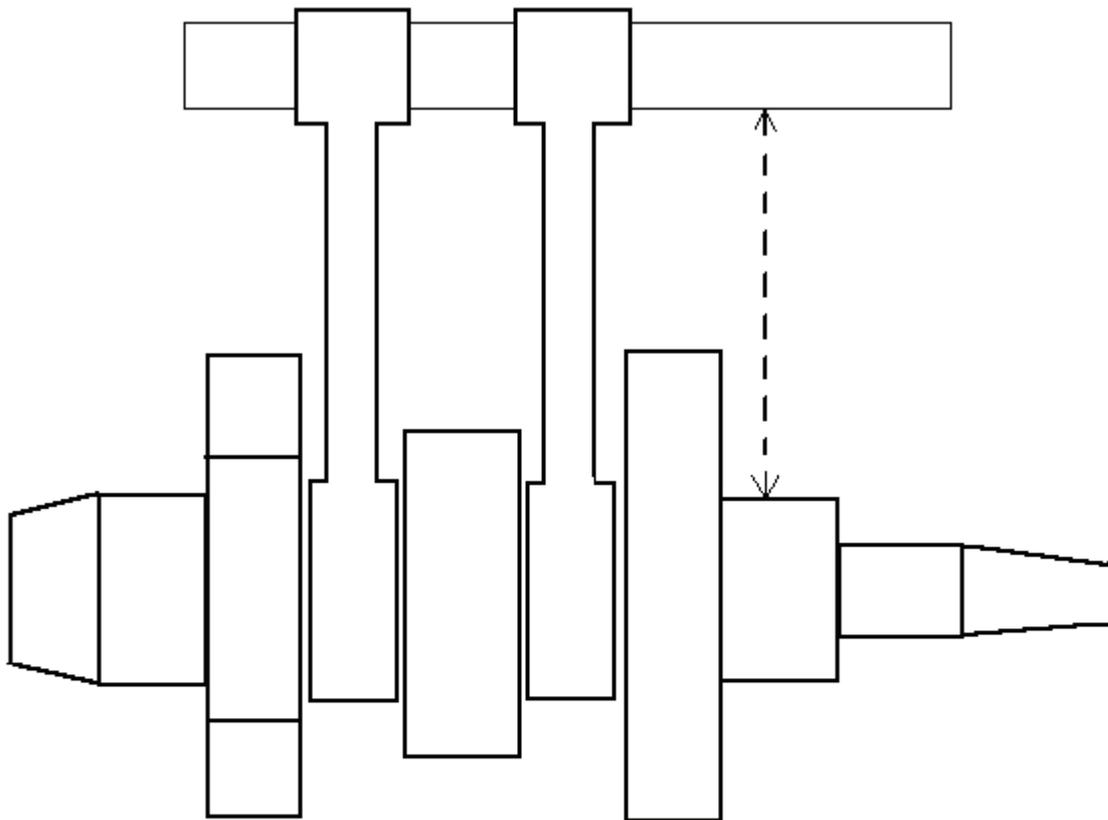
There is a much simpler method though (credit to Ed Korn!). You only need a reasonably straight 20 mm round

bar(maybe the piston pin is just long enough), that fits inside the small end bushes (all errors together within 0.05mm) and a dial caliper. Move both small ends to the same side and push the bar through both small end bushes. Measure the distance between the bar and the bearing journal. Rotate the rods to the other side and repeat. Both measurements should be equal.
